Case study: Paste plant retrofit

SUMMARY: A zinc, copper and lead mine located in Canada has recently restarted operations after several years under care and maintenance. The mine had an existing paste plant that was historically used for surface tailings deposition. The existing paste plant was overhauled and retrofitted to be able to handle full plant tailings and produce cemented pastefill that will achieve the required target strengths underground. In this case study, the various design challenges faced and lessons learned are documented which led to the successful retrofit of the paste plant in 2019.

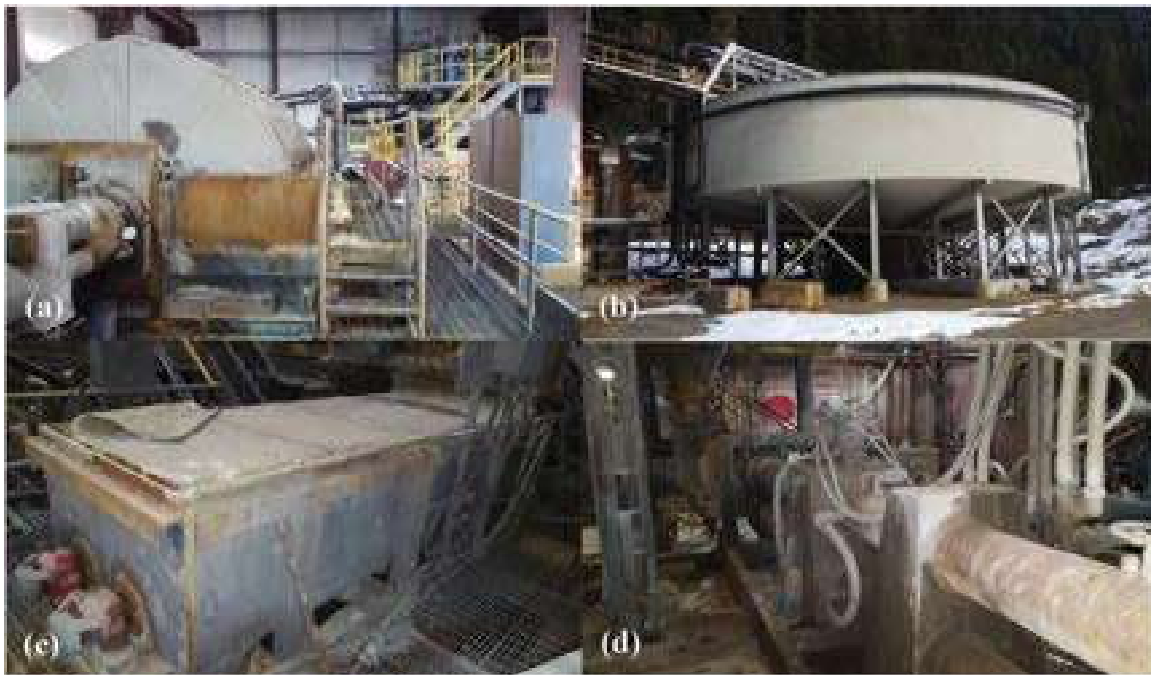
Tailings from the mill reports to a cyclone circuit located inside the paste plant (Figure 3a). The cyclone underflow is pumped to the hydraulic fill plant and the cyclone overflow is transferred to a 25 m diameter high compression thickener (Figure 3b). Thickened tailings (~60%*m*) is transferred directly to a single vacuum disc filter unit (Figure 3a) to achieve a cake moisture content of 22 to 26%. The filtration unit is a GL&V 3.2 m unit equipped with 12 discs and has a total filtration area of 173 m².

The filtered tailings and trim water were fed to a custom-made continuous twin-shaft mixer (Figure 3c). The discharge from the mixer was via an overflow which allowed paste to be gravity fed to one of two 100 bar rated Schwing KSP 110 V (HD) L (one duty/one standby) piston positive displacement pumps (Figure 3d). The piston pumps distributed the uncemented paste to the TSF.

Figure 3. Photos of existing paste plant, (a) view of disc filter (left) and cyclones (right); (b) view of thickener adjacent to paste plant; (c) continuous mixer; (d) positive displacement pumps.

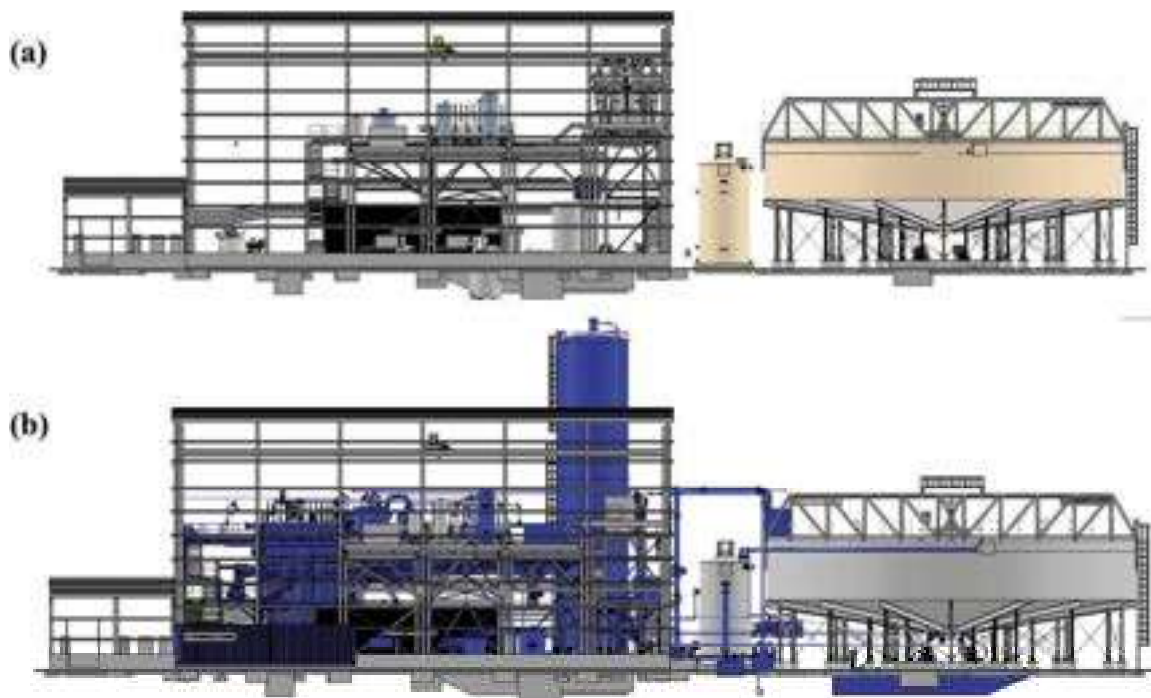
Figure 4. Comparison between (a) Existing 3D model and (b) As built 3D model (new equipment shown as blue).

The existing paste plant was redesigned to produce a cemented paste backfill product to support the mining activities while matching the overall mill utilization of 85 to 92%. A comparison between the existing paste plant 3D model and the as built 3D model complete with the new retrofits is presented in Figure 4.

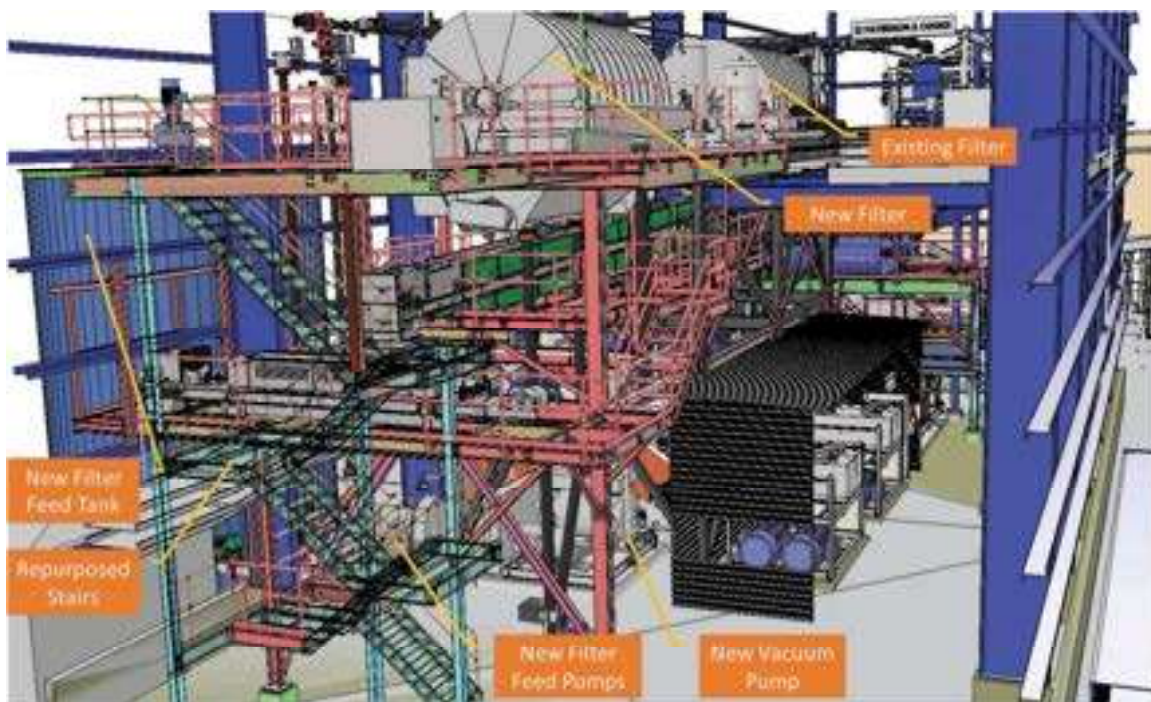
Figure 5. New extended support structure (Indicated as red) for second vacuum disc filter.

The support structure was extended to support the second filter (Figure 5 & 6). The existing flocculant plant was moved to where the cyclone underflow tank was located previously while the existing west staircase was moved over against the west side of the building. The new structure allows top access to the filter feed tank and agitator.

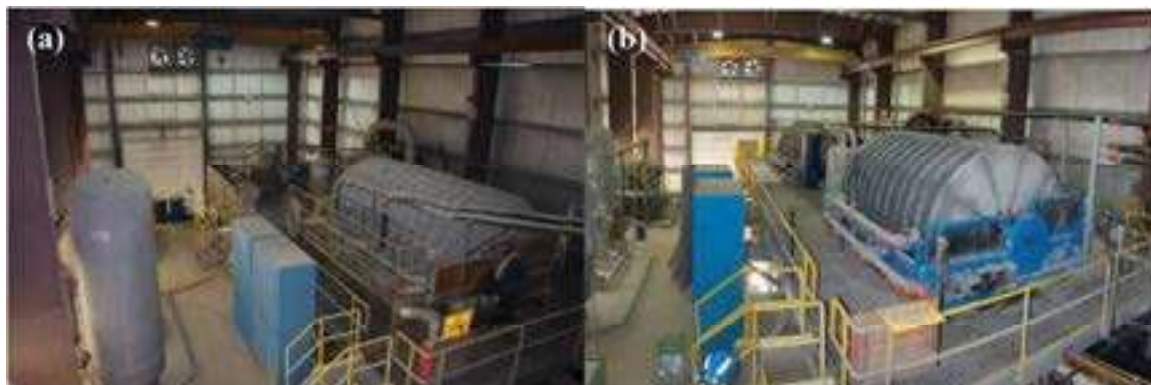
Figure 6. Comparison between (a) Existing filter level layout and (b) Retrofit filter level layout.

The existing vacuum disc filter was refurbished with a second 3.2 m dia. x 12 disc vacuum disc filter added to provide redundancy and/or boost the solids production capacity if required. The new filter was orientated in a left-hand configuration to compliment the right-hand configuration of the existing filter. This allowed both filtrate receivers and snap air tanks to be orientated in between the two disc filters optimizing the space available.

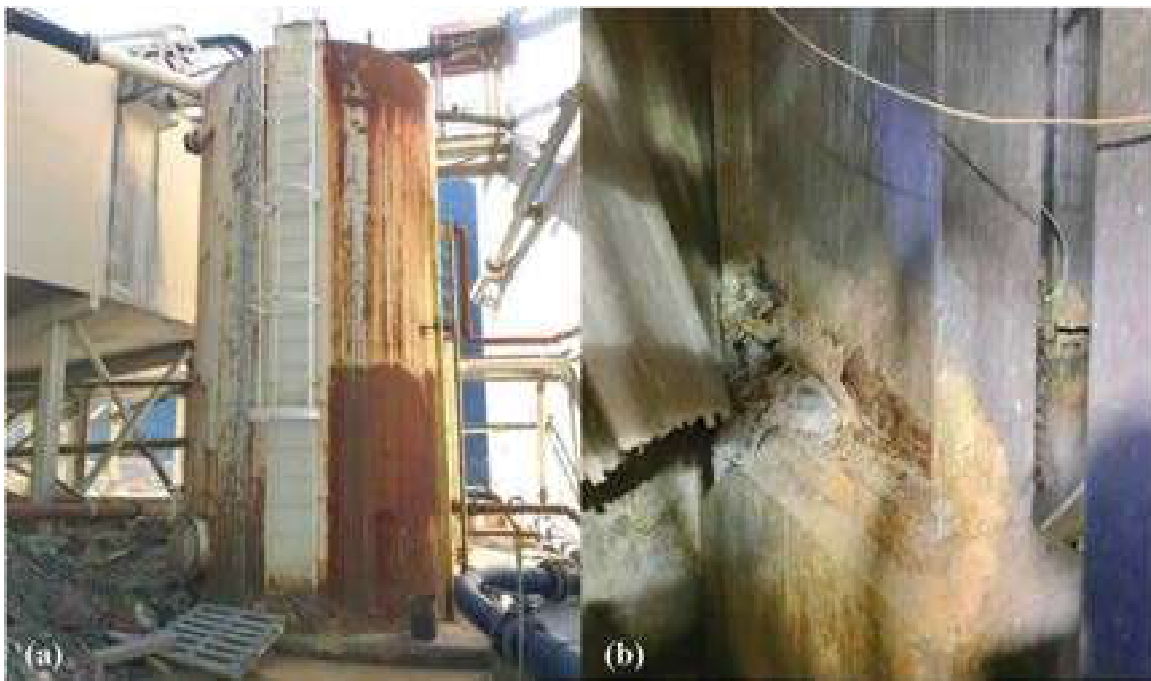
The process water tank had substantial corrosion and required a more involved remediation or complete replacement. The tank was opened to facilitate sandblasting and painting of the interior. An initial inspection of the tank interior was not done as all the inspection hatches were inoperable due to corrosion. As such, once the process water tank was opened, it was discovered that it was more than half full of tailings. Again, the use of a vacuum truck, pressure washers and labourers were employed to empty the tank.

Initial inspections were conducted to determine the condition of the structure, equipment and tanks that would be reused in the retrofit. While most of the structure was in good condition, any steel that had been in contact with tailings was corroded and required remediation (Figure 7). Fortunately, the equipment and structure with the most significant corrosion and those that had seen resourceful repairs by plant staff were to anyway be replaced by new equipment and structural steel as part of the retrofit. These included the filter cake conveyor, paste mixer and mixer platform structures. The remaining structural members that had minor contact with tailings spillage were sand blasted or wheel abraded in place and coated with a two-part epoxy to protect from future exposure.

Figure 7. Examples of existing equipment corroded from contact with tailings (a) Process water tank and (b) Building column.

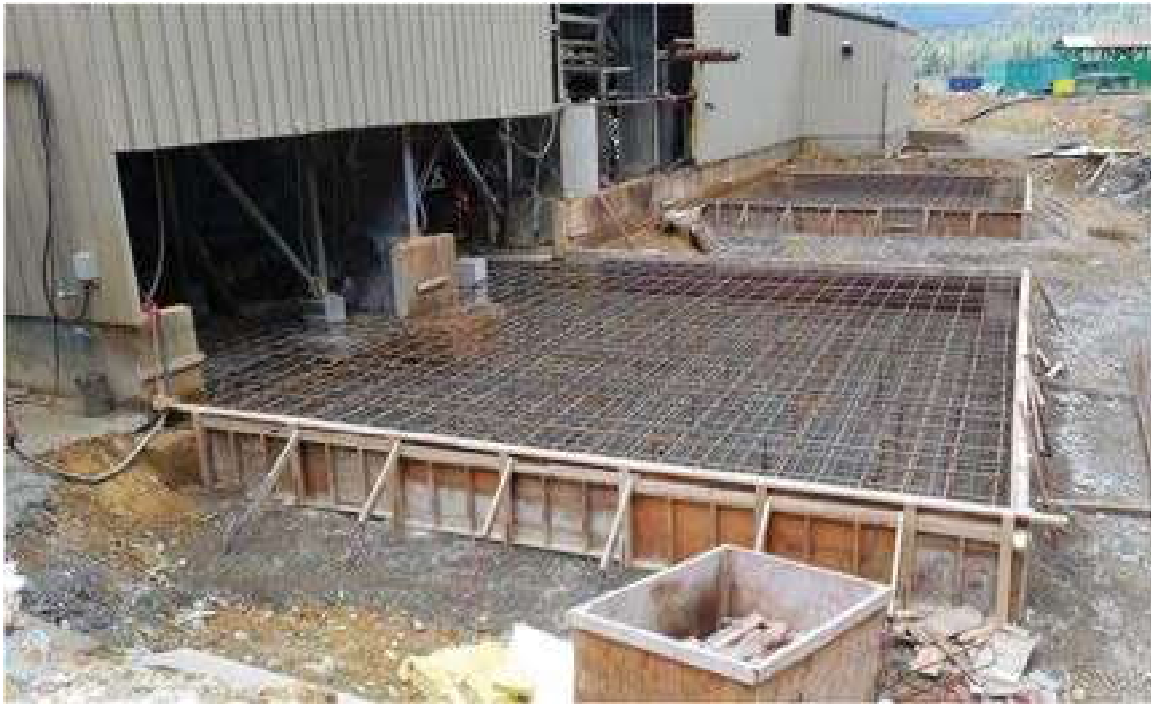
The silo layout was based on geotechnical assumptions before the commencement of the detailed design and the allowable soil loads could be determined. When past geotechnical data and reports were reviewed, it was found that the existing plant subgrade was largely fill material and the existing building and equipment footings were placed on dynamically compacted subgrade. Furthermore, the densification required for construction was performed only in areas where the footings were constructed in 2002 and the condition of the surrounding grade was unknown. A follow-up geotechnical investigation confirmed that the soils were composed of “*mixed organics, mine waste rock, and other mine waste materials*” to a depth of 3.3 m and limited the allowable soil bearing capacity to 75 kPa.

As per the geotechnical findings and resultant loads, calculations required a raft footing of 10.7 m by 10.2 m to resist to overturning moment of the relatively tall silo and high load. The site layout, however, set the distance from the centreline of the silo to the outside of the existing building to only 3.345 m. This accordingly required that the silo foundation to encroach into the building by over 2 m via concrete and rebar to tie into the structural steel supporting footings on the building’s interior. When the need for a large raft footing was determined, a design review was called to determine alternatives. Options reviewed included silo relocation, pile foundations and anchoring to a nearby rock slope. In the end, the raft footing design was retained which resulted in construction sequence modifications.

Figure 8. Silo and filter feed tank raft footings.

The design challenges that were faced with the binder silo foundation also created additional construction challenges. In order to properly construct the foundation, the stem wall to the building had to be cut out and removed and the floor in the north east corner of the plant was saw-cut and removed. Rebar for the silo foundation was specified as Ø25 mm bar, layered at ~200 mm spacings. To effectively tie the foundation into the interior structural footings, it was necessary to extend the bar into the building and dowel into the existing concrete before pouring new concrete around it (Figure 8).

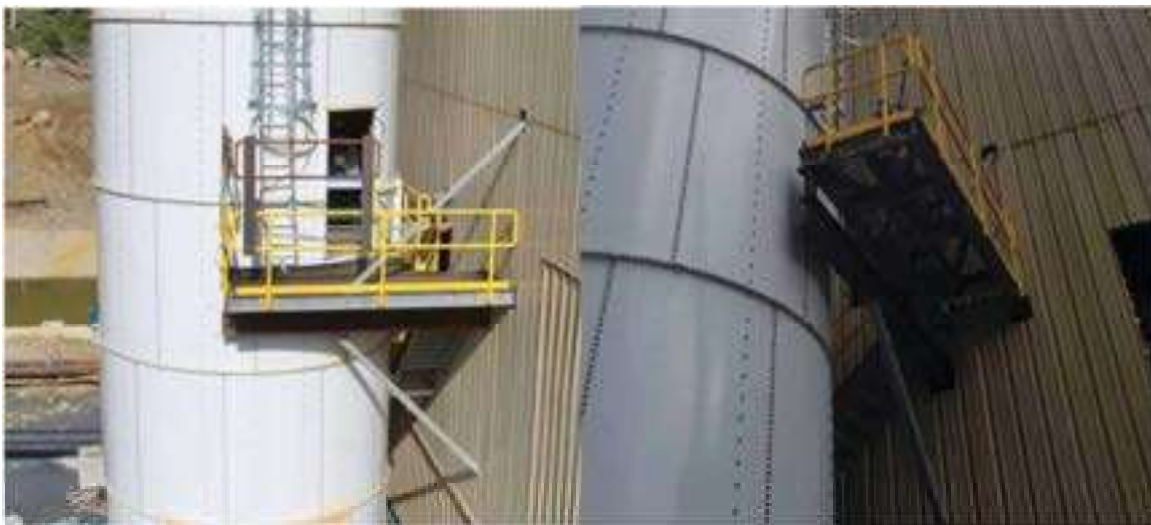
The challenges associated with the design of the cantilevered access platform were realized because the precise location of the silo could not be predicted by the design team, partly because of the necessity to situate the base ring wherever the anchor bolts could be drilled around the rebar in the concrete. The resulting stair and platform (Figure 9) are functional although it required site modifications to limit the deflections and minimize the gap between the platform and silo entrance.

Figure 9. Cantilever staircase to access binder system.

Once the silo foundation design was finalized, the necessary access bridge could be detailed to connect the interior mixer deck to the silo. The initial intention was for a short stair run and platform that would be attached to both ends; one to the silo and the other to the interior mixer deck. It was subsequently found that no provision for loads or attachments of a platform had been made on the skirted silo design. The access platform and staircase therefore needed to be completely supported from the mixer deck structure which required a creative design effort due to limited anchoring members being available. Furthermore, the cantilever platform required a 90° turn which needed to be incorporated into the support design.

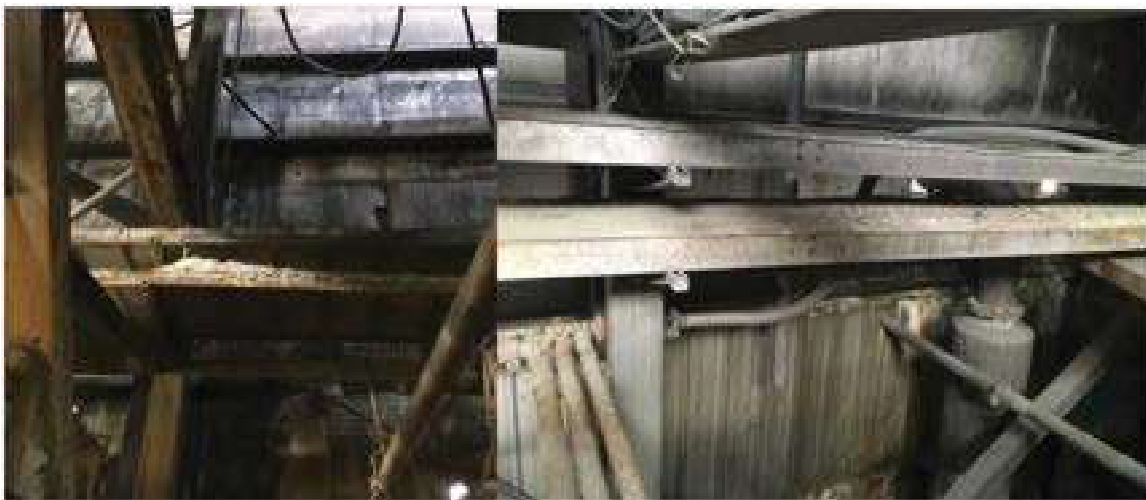
The inspection of the cable runs revealed that the cable trays were both overloaded and covered in tailings. Large sections of cable trays were replaced due to poor condition arising from corrosion (Figure 10). Electrical cabling suffered the same fate with large quantities of it being replaced due to cracked sheathing and great difficulties in identifying which cables were in good conditions and which not. The poor condition of the cables and trays in the plant ended up being significant both in terms of cost and having a negative impact on the project schedule.

Figure 10. Cable tray's full and corroded/full of tailings.
